# **SALUDA DAM, THEN AND NOW**

*Elena Sossenkina, Monitoring Coordinator, Paul C. Rizzo Associates  
Scott G. Newhouse, P.E. Senior Engineer, Paul C. Rizzo Associates  
Samuel H. Moxley, P.E. Construction Engineer, South Carolina Electric and Gas Company*

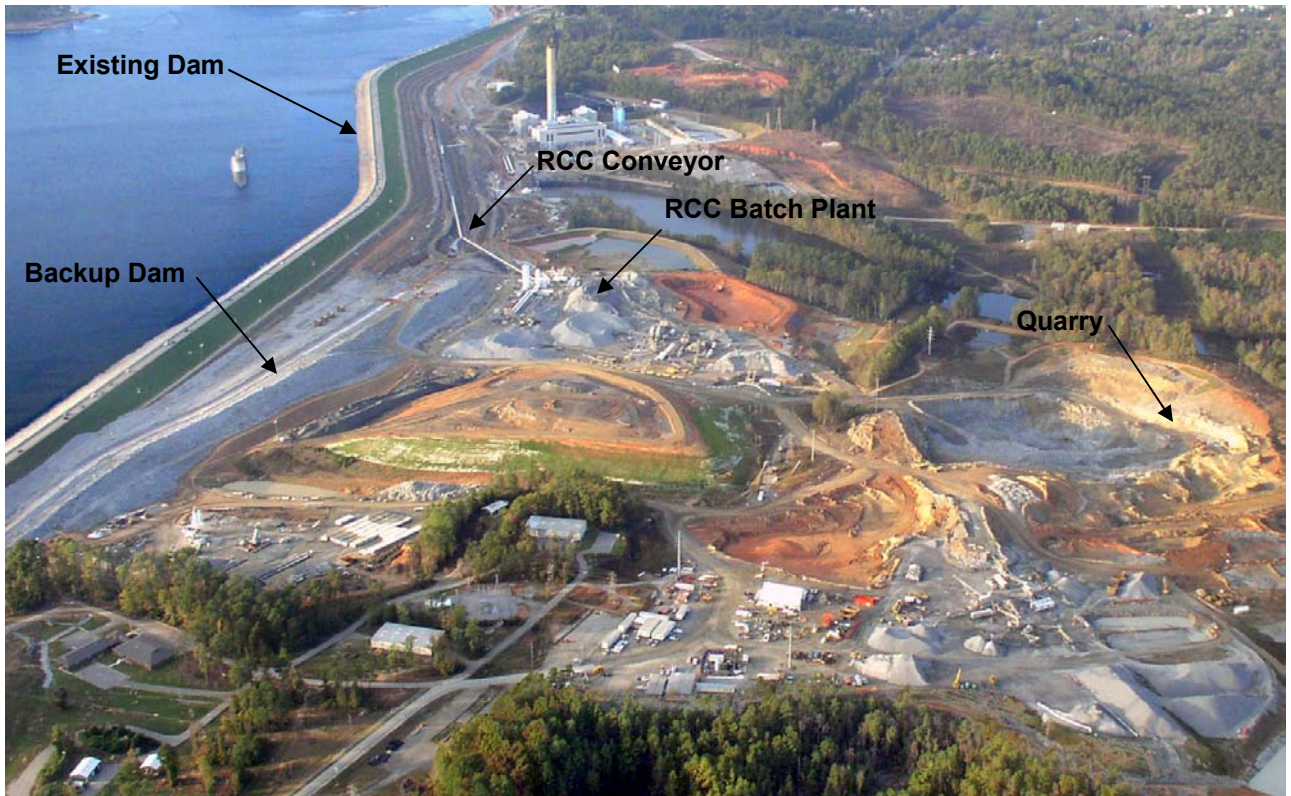
**Figure 1 Project Site**

The Saluda Dam is currently being remediated to meet modern seismic safety requirements. An interesting aspect of the remediation is that it requires that Saluda Dam is built on the same site for the second time. Figures 1 and 2 provide an overview of the site and illustrate the Dam's size and geometry. The Dam is classified as a high hazard dam; an uncontrolled breach of the Dam would cause a downstream flood near the City of Columbia, probably entailing loss of life. Studies indicate that about 120,000 people would be at risk.

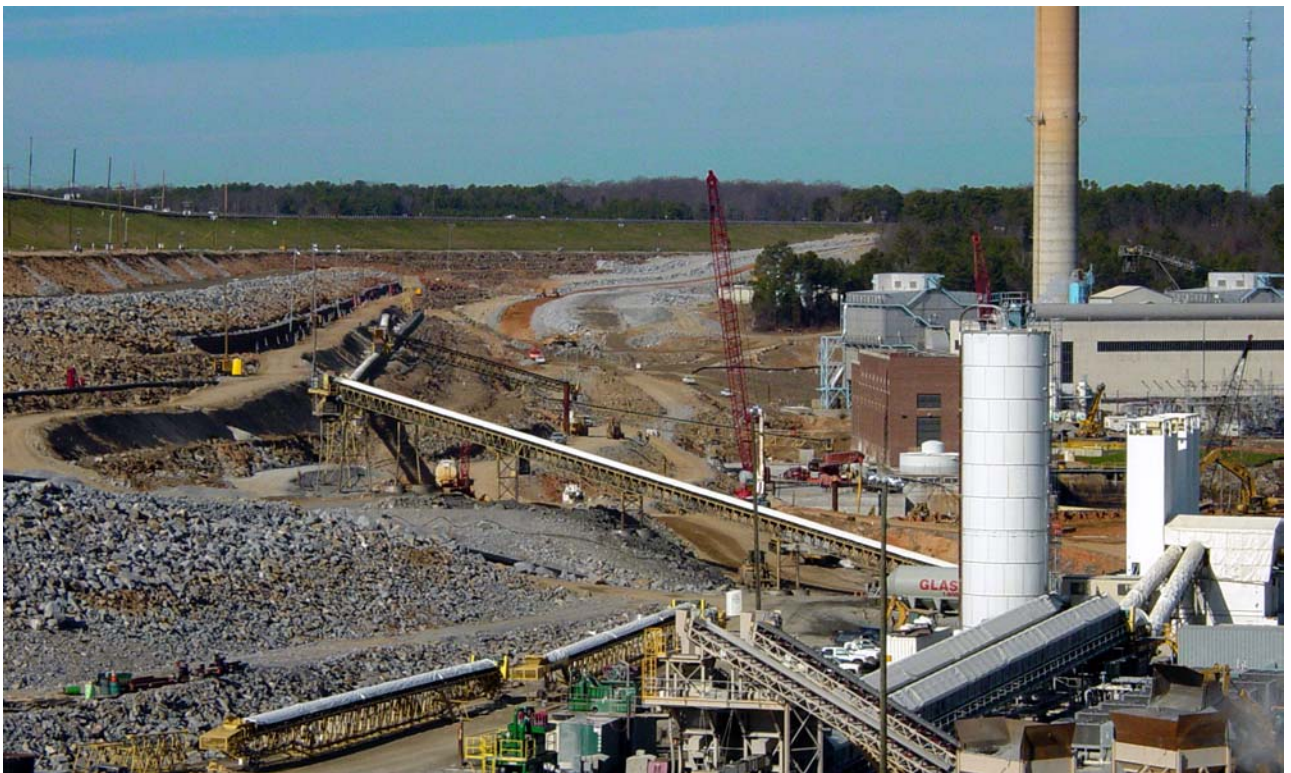
**Figure 2 RCC Batch Plant and Conveyor**

The RCC section of the Dam is built using conveyors. RCC is delivered to the Dam from the batch plant along a conveyor, as seen on Figure 2. The conveyor runs 3,200 ft along a bench above the excavation from one end of the RCC section to the opposite end. This conveyor provides an interesting comparison to the 1920s railways that were erected along the existing Dam. Where in the 2000s the material is RCC moved along the Dam's length by conveyor, in the 1920s the railway moved soil fill along the Dam. The construction problem was essentially the same, and the solutions are similar- reflecting technology then and now. With trucks and conveyors more than 12,800 cy of RCC and 20,000 cy of soil or rockfill can be placed in a single day.

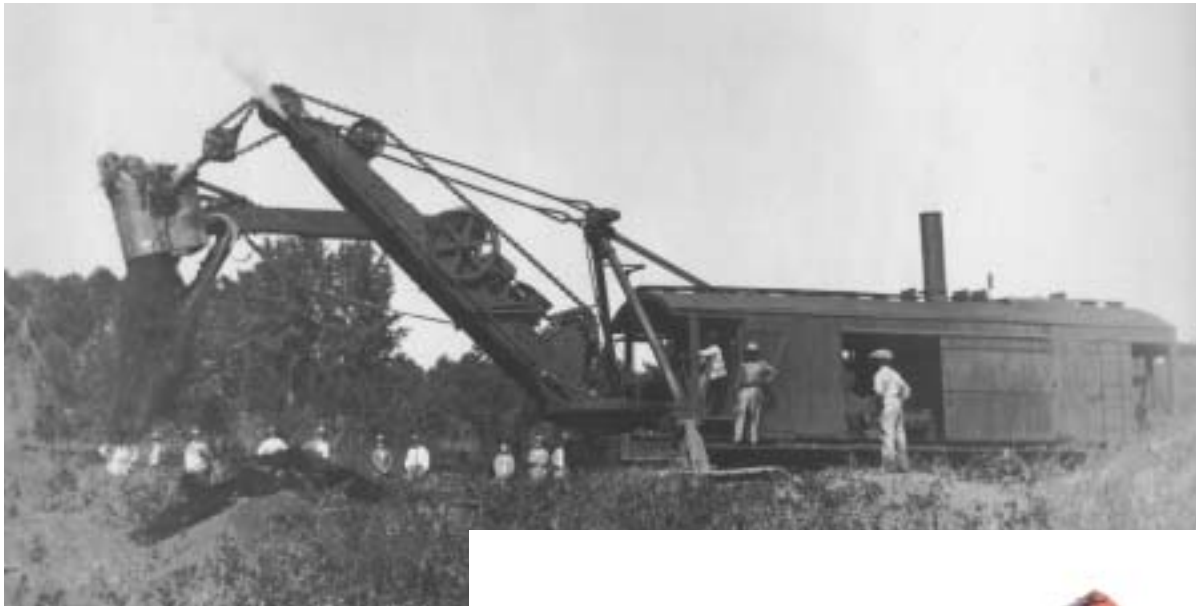
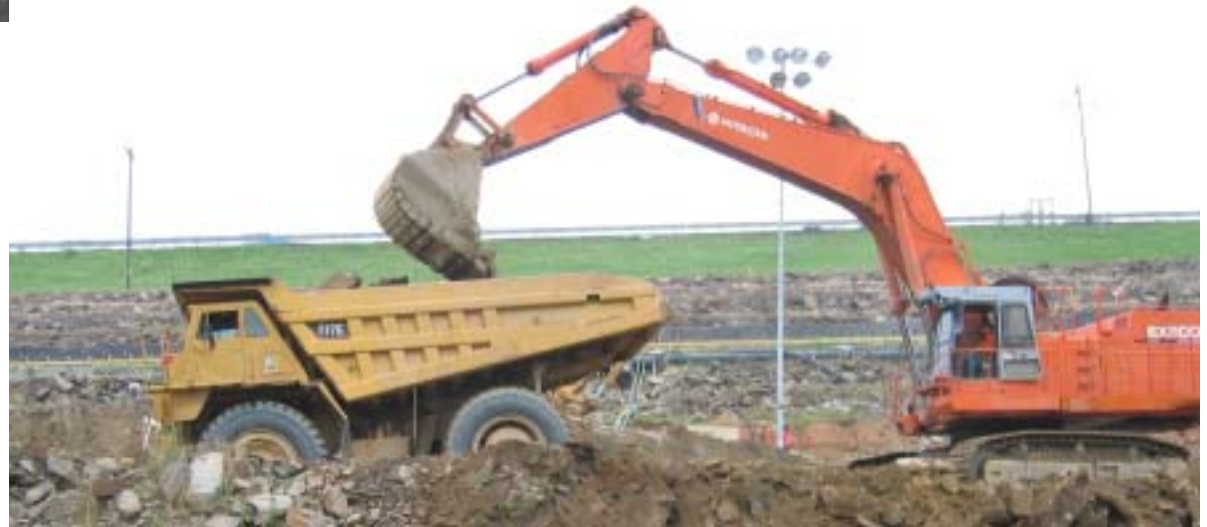
**FIGURE 6** Equipment used for construction

Earth fill was excavated from borrow pits adjacent to the Dam site by means of 12 steam-shovels, shown on Figure 6, which loaded it onto trains. The transportation equipment consisted of 17 standard gauge locomotives, two narrow gauge locomotives and 180 dump cars. With an average haul of about a mile from the borrow pits to the Dam, the daily transportation totaled about 300 train loads or 2,000 cars.

Saluda Dam Construction, 1929

Backup Dam Construction, 2003

Daily blasting in the borrow area provides rock for the construction. Haul roads lead from the borrow area to the crushers, and directly to the rockfill Dam sections. A fleet of 10 heavy haul trucks (CAT 777 and CAT 773) take the soil overburden from the borrow area and blasted rock directly to the new Dam, where it is placed and compacted to create the core and the outer shells. Blasted rock is also taken to the primary crusher and broken to make all products for the Dam: select rockfill; fine and coarse filters, and RCC aggregates. Fifteen 40 ton trucks take filter materials and select rockfill from the crusher plant to the rockfill Dam. RCC aggregates are fed from the crusher plant into the RCC batch plant.
