Project Profile – Indoor Coliseum Structural Monitoring

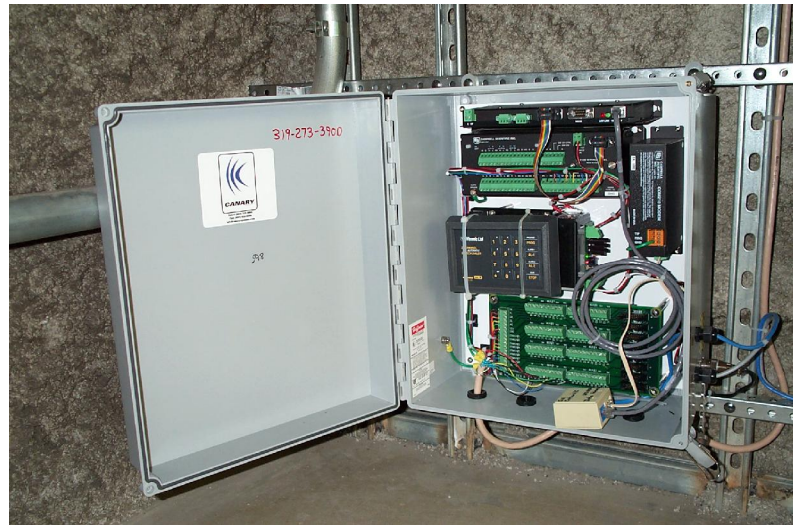
We supplied a MultiLogger System to read the wind speed and direction sensors as well as the vibrating wire strain gages, connected to (2) Canary Systems MultiMux instrument multiplexers. MultiLogger software was also provided to facilitate programming of the system, monitoring, management of alarms and data collection.
