LISTENING TO THE DAM- INSTRUMENTATION AND MONITORING PROGRAM SALUDA DAM REMEDIATION

*Elena Sossenkina, Monitoring Coordinator
Matt Glunt, E.I.T. Field Engineer
Joseph A. Mann, E.I.T. Field Engineer
Scott G. Newhouse, P.E. Senior Engineer,
Paul C. Rizzo Associates, Monroeville, PA*

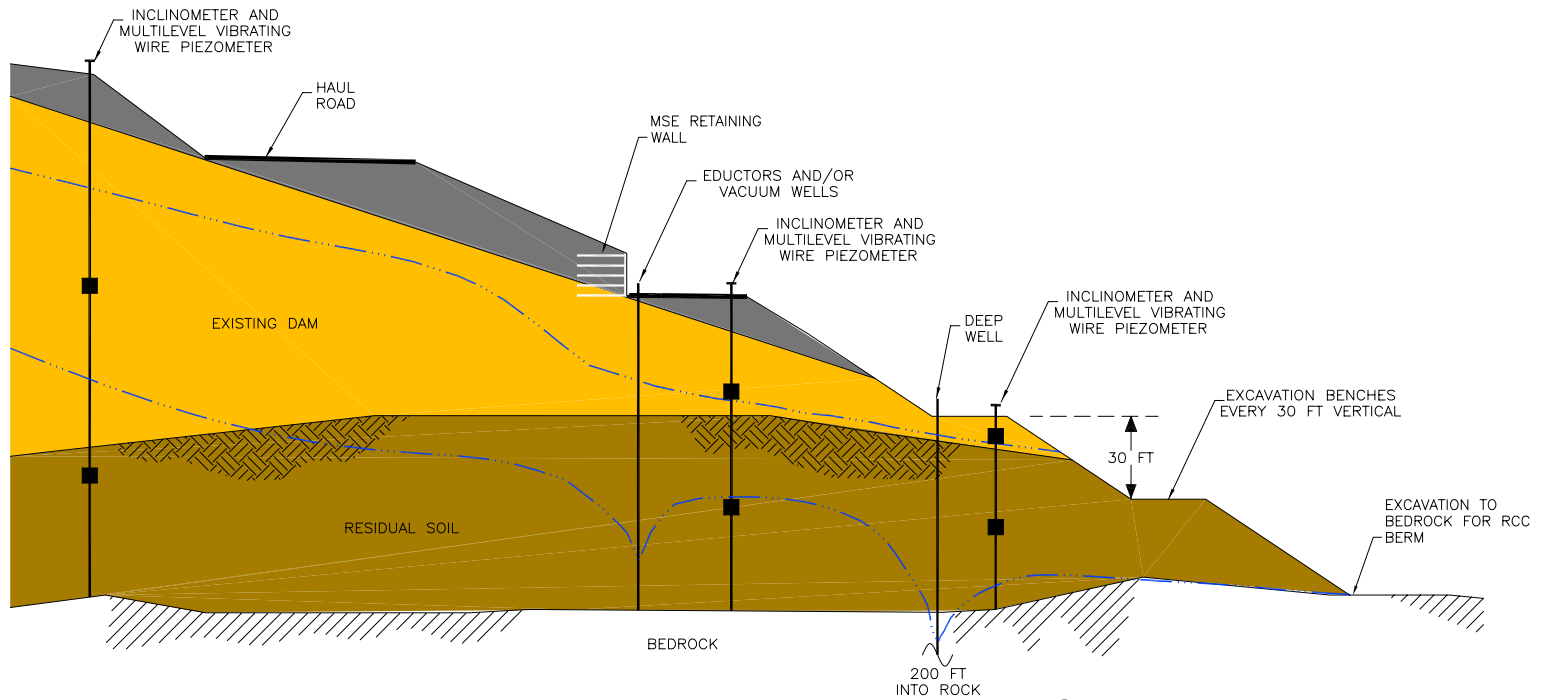
Figure 2 - Typical Excavation and Dewatering System

Typically, three rows of inclinometers are installed above each excavation cell, as shown on Figure 2, with more than 80 for the entire Dam. Typical depth of inclinometers on the project varies from 50 ft to 140 ft. Most of them extend down to weathered rock. However, where the foundation soil layer is thick the casing is terminated in competent residual (foundation) soil.

To facilitate construction of the Rockfill Berm, a haul road was built along the downstream face of the Dam, as shown on Figure 2. The 45 ft-wide road was perched on a bench along the downstream slope, nearly 100 ft above the excavation cut slope at the Dam's toe. During road construction, inclinometers installed on a bench downstream of the road indicated movement of a characteristic bulge shape, shown on Figure 5b. The response was brought on by adding the bench to the Dam (surcharge loading), and load by heavy haul trucks. This was an anticipated reaction of the loose embankment fill to applied stress. In this case, the deformation was considered tolerable, requiring no restriction on construction activities.

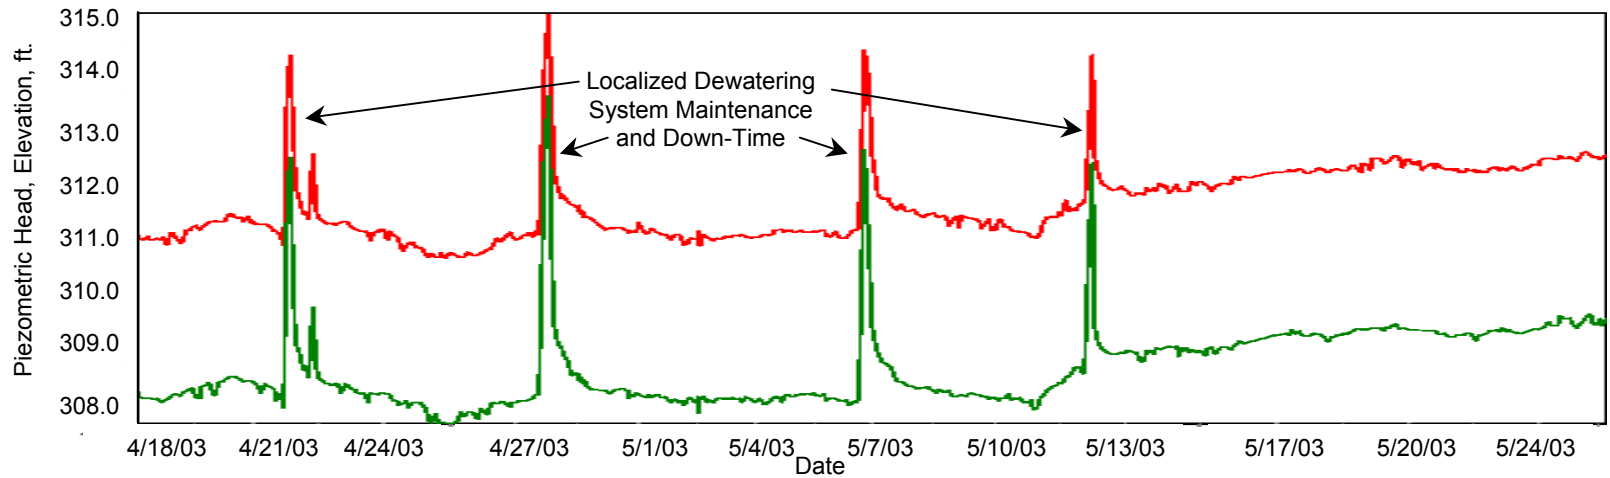
Figure 3 - Piezometer Data Typical Response to Dewatering Shutdown

component, or it may be due to shear developing in the excavated slope. As shown on Figure 3, the vibrating wire piezometers show a characteristic response to shutdown of nearby dewatering components. This recognizable response pattern allows engineers to determine the cause of the rise and to gauge the severity of the situation. Piezometer data is also used to evaluate effect of abandoning the dewatering system in excavation cells that have been backfilled.

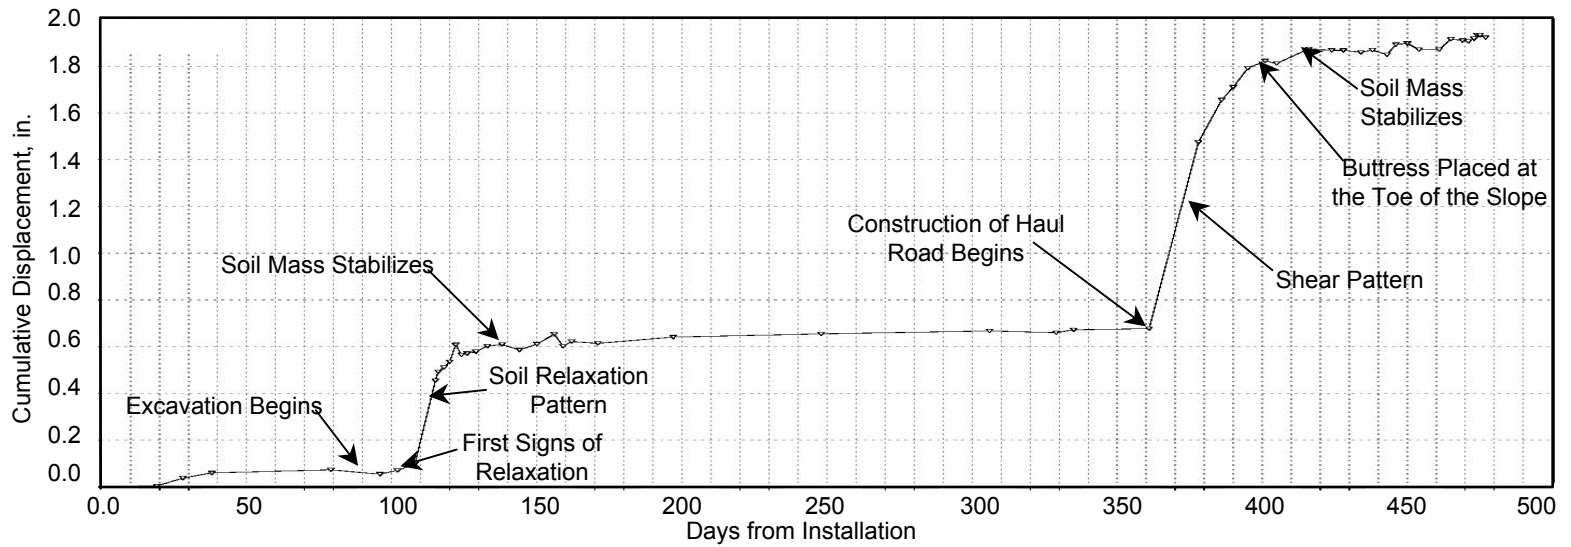
Figure 4 - Typical Inclinometer Time Displacement Plot Correlated with Construction Activities

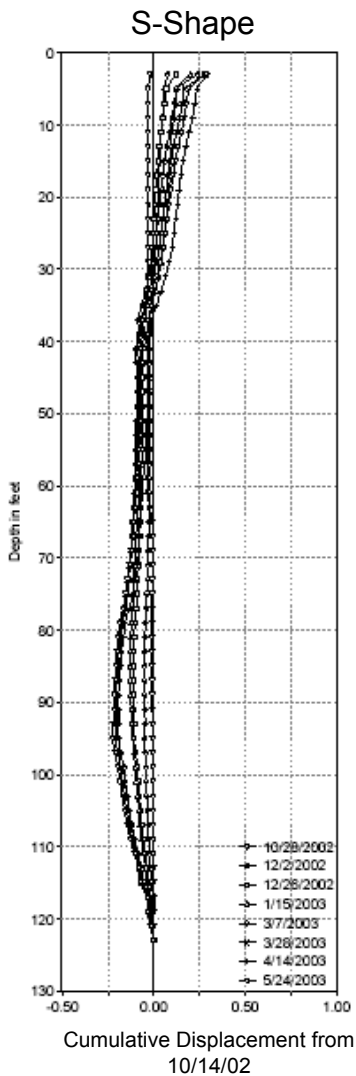
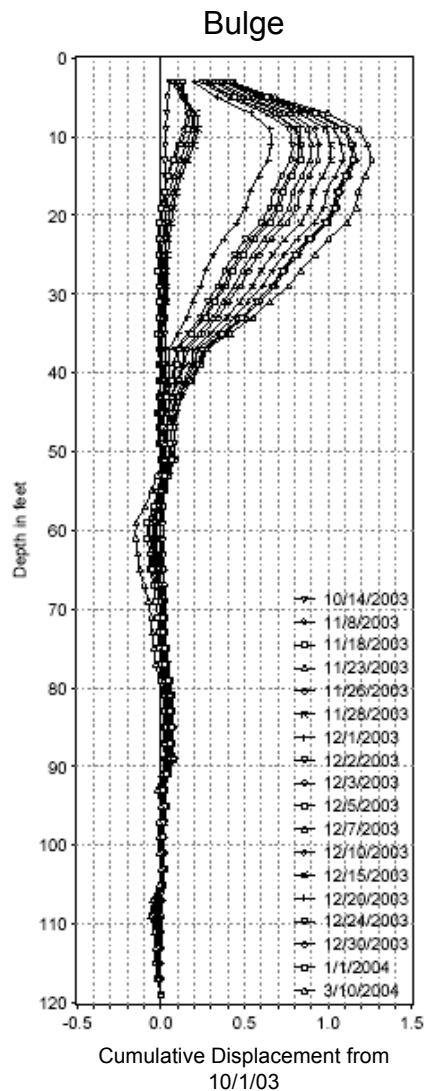
Figure 5 - Typical Incliniometer Plots

As excavation progresses and toe support is removed, engineers expect some resulting deformation within the Dam. The instrumentation team's challenge in interpretation of the inclinometer data is deciding if a movement is a normal, expected response of the Dam, or the onset of a slope failure. The team must evaluate the depth, magnitude, rate, and location of the deformation and attempt to correlate it to specific construction activities, as shown on Figure 4. Engineers noticed that reaction to certain construction activities produced inclinometer data plots of a distinct characteristic shape. The team categorized inclinometer data plots into 4 categories, shown on Figure 5, based on shape of the data plot and nearby construction activity:

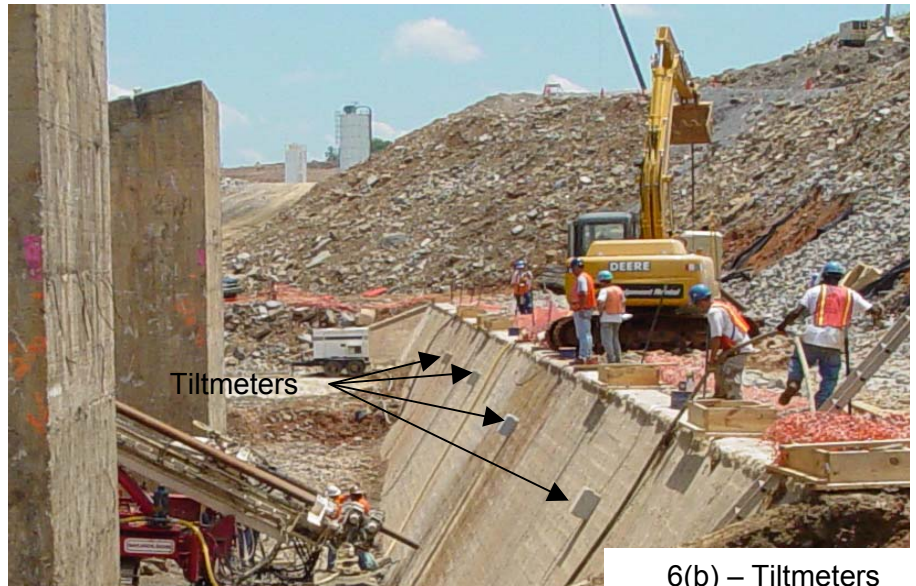
6(b) - Tiltmeters

Vibrating wire tiltmeters, shown on Figure 6b, were deployed to monitor movement of important structures during excavation activities. Tiltmeters were installed on overhead circulating water pipes and on an old gravity wall uncovered by the excavation. The 72 in. diameter circulating water pipes are connected to Dam penstocks and supply cooling water to the nearby coal-fired plant. Highly erratic movement (± 0.5 degrees) was recorded by the tiltmeters installed on the pipes. Inspection of the pipe indicated no signs of distress. After the unsuccessful attempt to correlate the data with nearby excavation activities, engineers were left with a puzzle. What caused these massive pipes to vibrate so much? After further investigation, it was noticed that certain fluctuations coincided well with opening and closing gates at the hydropower station. Engineers suggested that the observed vibrations are caused by water hammer forces. A field test was performed under extensive monitoring to confirm this conclusion. Other factors that contributed to the abnormalities included jolting of the instrument during nearby activity and daily fluctuations due to ambient temperature change.

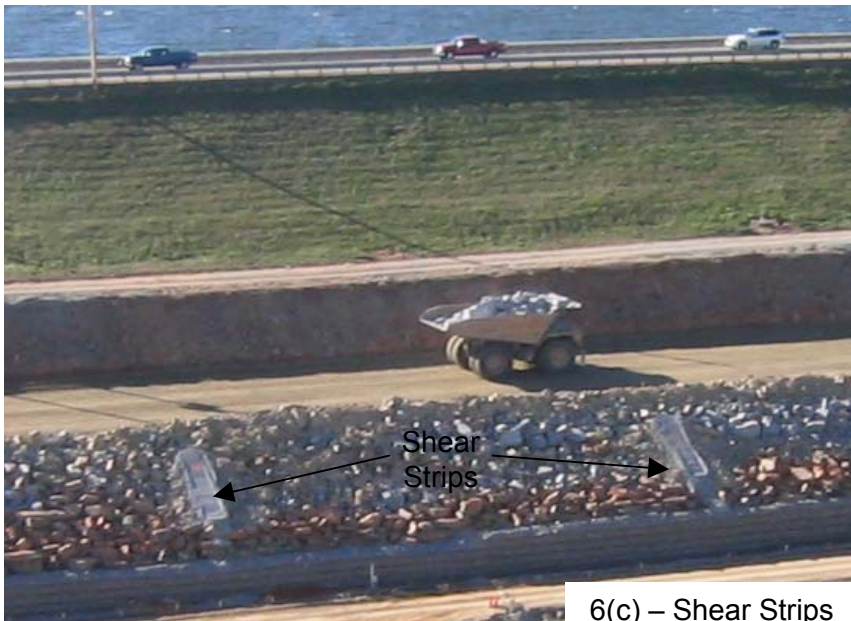
6(c) - Shear Strips

Additional surface instrumentation, shown on Figure 6 was used to aid in visual observation. Strips of unreinforced concrete (shear strips) were placed on the surface of the slopes (Figure 6c). Pipe lasers (Figure 6d) were utilized to monitor a line of targets installed along the cut slope to gauge movement of the slope. Theoretically, surface movements would cause readily visible relative movement in a laser line or a crack in a shear strip and could help define the lateral extent of the movement. Survey monuments were monitored with GPS for any horizontal or vertical displacement. Thus far, GPS surveying has correlated well with inclinometer indications and calculations of expected values for settlement and lateral displacement of the ground surface. The other tools, i.e. laser lines and shear strips, have been found to be inconclusive and easily disturbed.

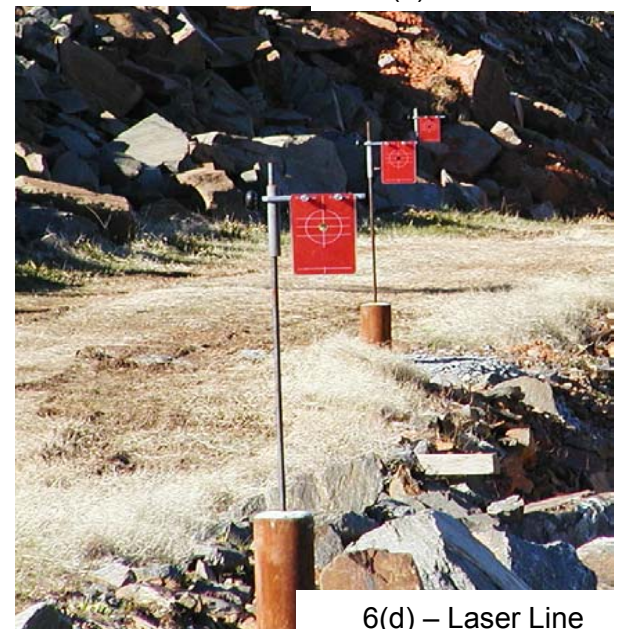
6(d) - Laser Line
